LANDSLIDES AND RELATED FEATURES

OF THE MOUNT AIRY, TENN. QUADRANGLE

by
Roger E. Thomas
1981

U.S. Geological Survey
OPEN FILE MAP 81-1318 (D-6)

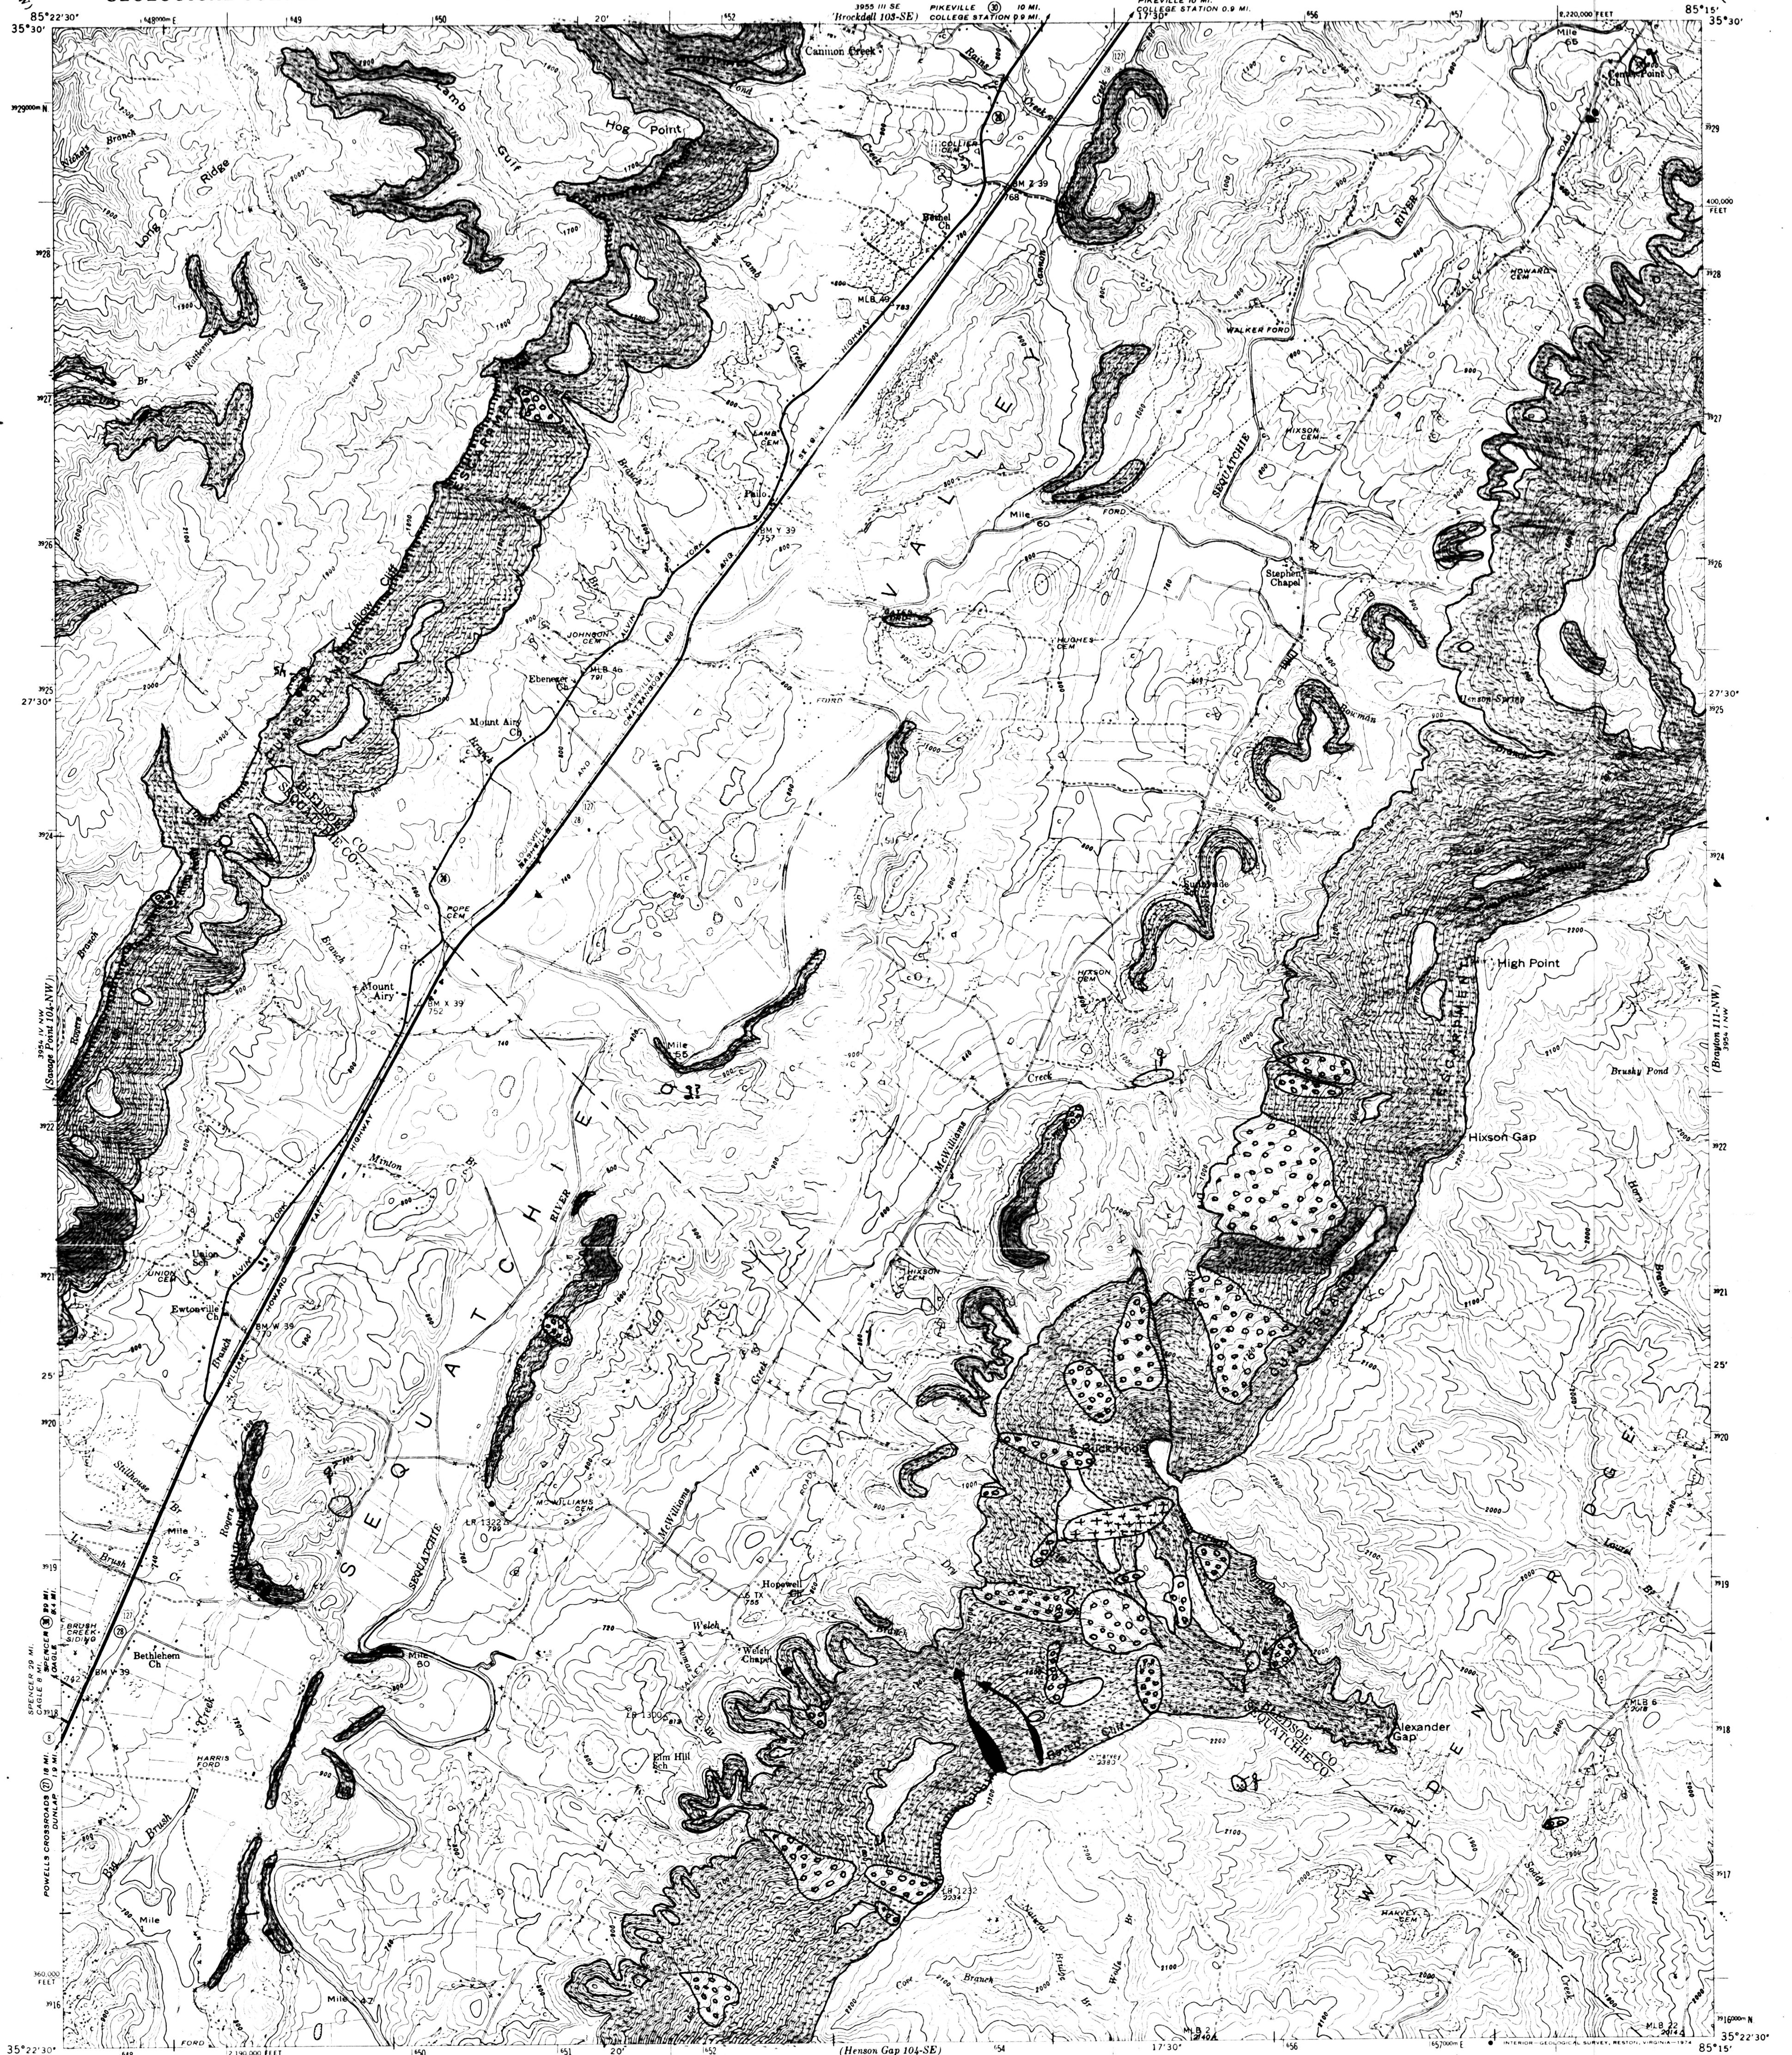
Landslides and related features interpreted
from aerial photographs:
1:79,000 (Black and White) 1974
1:20,000 (Black and White) 1970

Photointerpretation and field check 1981

ACTIVE OR RECENTLY ACTIVE LANDSLIDE
Complex landslide composed of earthflow, debris
slide, earth and rock slump. Identified from
historical records, and from scars, debris and
other field evidence. Ground extremely unstable;
sliding accelerated by excavation, loading and
changes in drainage conditions. May include
areas with several active slides too small to
be shown separately. Questioned where doubtful.

OLD LANDSLIDE
Area of extensive hummocky ground caused by
earthflow and earth and rock slump. Lacks
clear evidence of active sliding. Relatively
stable in natural, undisturbed state,
generally not affected by small structures properly
sited in areas away from the edge of the toe;
can be reactivated by extensive, rapid exca-
vation, loading, and changes in ground water and
surface water conditions. Area of old landslide
probably includes recent ones not identified
from field evidence or otherwise documented.
Upslope boundary of landslide generally defined
by modified scarp, but downslope (toe) may be
gradational and not well defined. Questioned
where doubtful.

COMBINATION LANDSLIDE
Area of recent and old slides in which
individual slides are not identified.

COLLUVIAL SLOPE
Valley wall along major streams with slope as
steep as 40 (85%); stony, clayey silt soil up
to 50 ft. (15 m) thick; commonly buttressed by
a terrace or bench at the toe of the slope; very
susceptible to sliding by cutting of toe area,
removal of terrace or bench, and overloading;
slide commonly activated without apparent cause.

COLLUVIAL SLOPES WITH LANDSLIDES
Landslides too small or obscure to map
individually.

**AREAS SUSCEPTIBLE TO DEBRIS FLOWS AND DEBRIS
AVAILANCES**
Primarily shallow, narrow ravines and chutes with
accumulation of stony colluvium generally 10 ft.
(3 m) or less in thickness; susceptible to rapid
movement during intense rainfall. Most ravines
and chutes designated show evidence of former
debris flows and avalanches.

AREAS SUSCEPTIBLE TO ROCKFALL
Steep, locally vertical, natural and man-made
slopes and cliffs, 15 ft. (4.5 m) or more high;
formed dominantly of sandstone, limestone, sandy
shale, mudstone and claystone. Interbedded mud-
stone, claystone and shale weather rapidly leaving
sandstone and limestone rock faces unsupported.

SOIL AND ROCK SUSCEPTIBLE TO LANDSLIDING
Soil and rock similar to that involved in land-
slides elsewhere in map area; primarily areas
underlain by claystone, mudstone and shale
associated with other rock types. Rock weathers
rapidly on exposure forming clayey soil highly
susceptible to sliding. Includes covers (U-shaped,
shallow valleys) containing thick layers of clayey
soil that are very susceptible to sliding where
excavation breaks continuity of slope and where
overloaded by artificial fill.

AREAS LEAST PRONE TO LANDSLIDES
Map areas in which no patterns or symbols are shown;
primarily valley floors, ridge tops and broad
benches; modification by excavation and fill may
lead to local landslides.

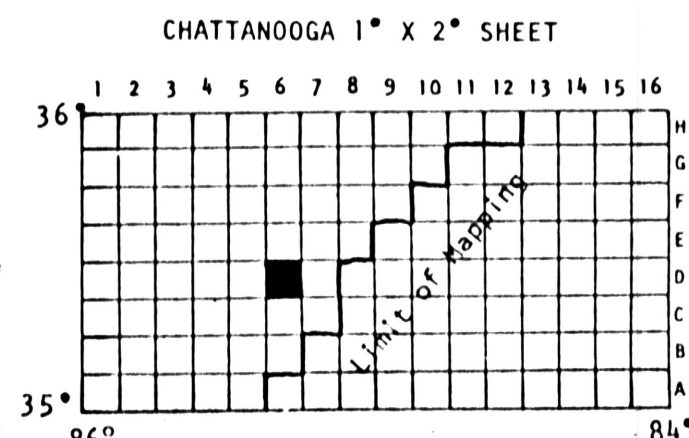
The first six digits of the open file number designate the
specific 1:250,000 scale map sheet of which this quadrangle
is a part. The last two digits designate the position of the
quadrangle in a subdivision of the 1:250,000 scale map based
on rows and tiers shown in the diagram to the right. The
location of this quadrangle is shown by the black square.
